New York State Department of Transportation

Yellow Flag NB22CTW021

BIN: 1065318

Feature Carried: 278I278IX2M23027

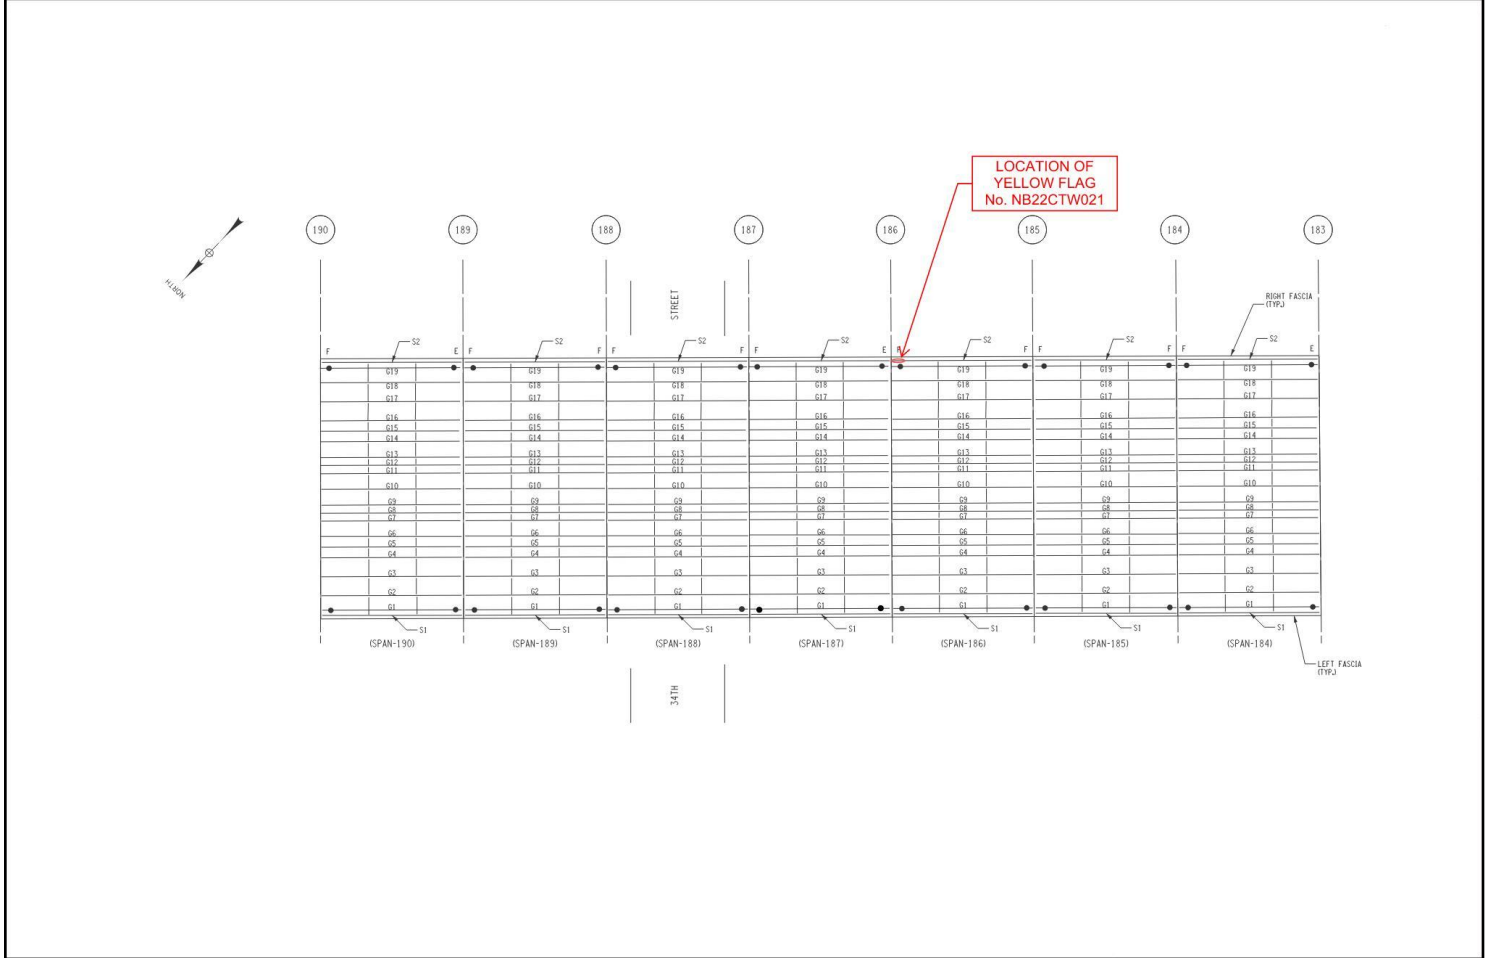
Photo Filename: **Span 186 - Framing Plan.jpg**

Attachment Description: Span 186 - Framing Plan

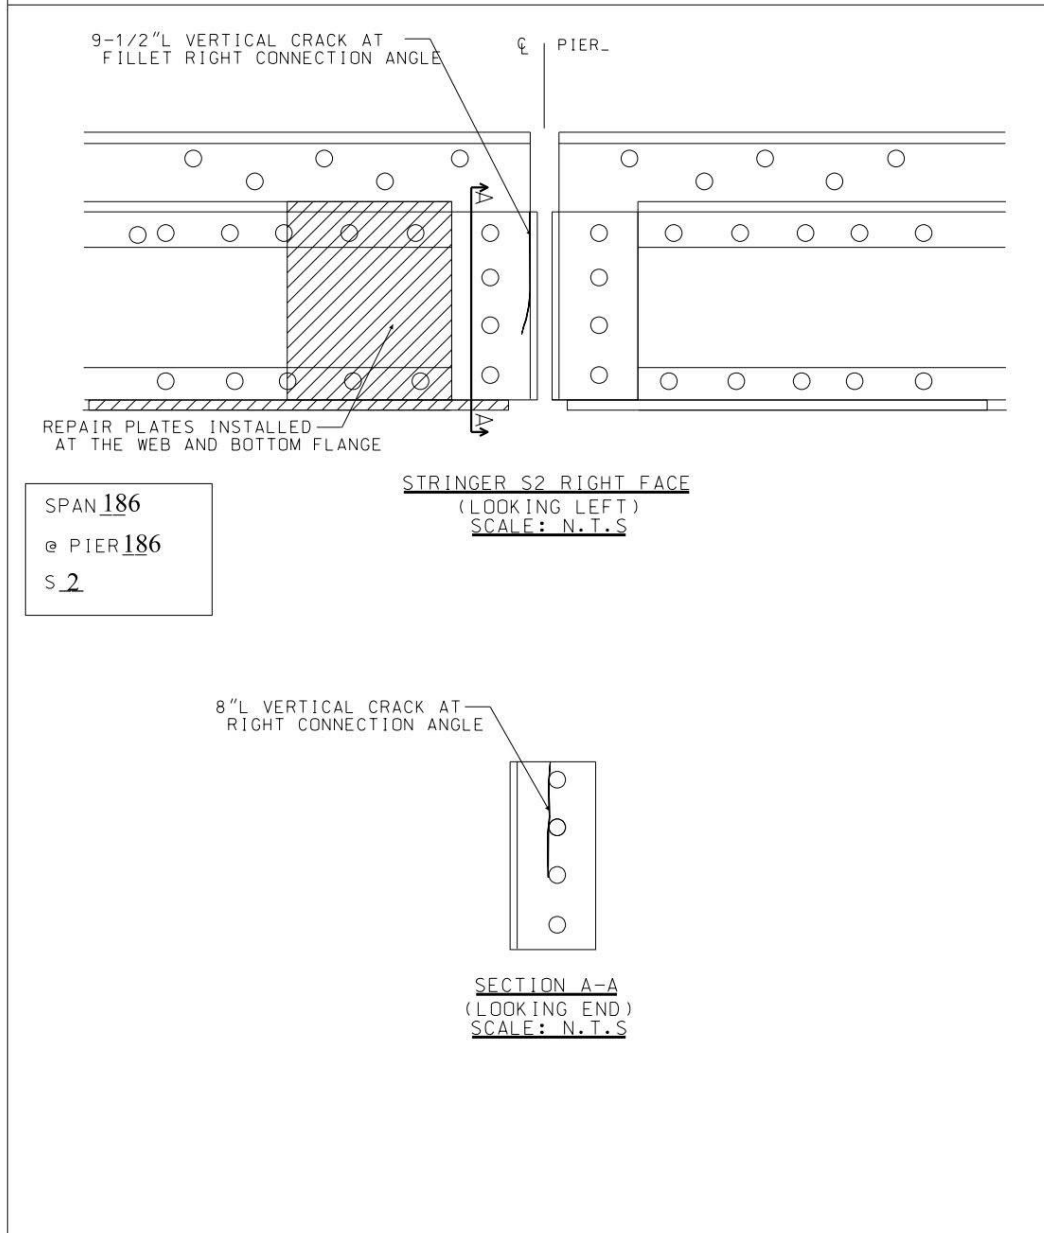
Photo Filename: Flag Detail Sketch.jpg

Location: S2 @ Pier 186

Attachment Description: Flag Detail Sketch

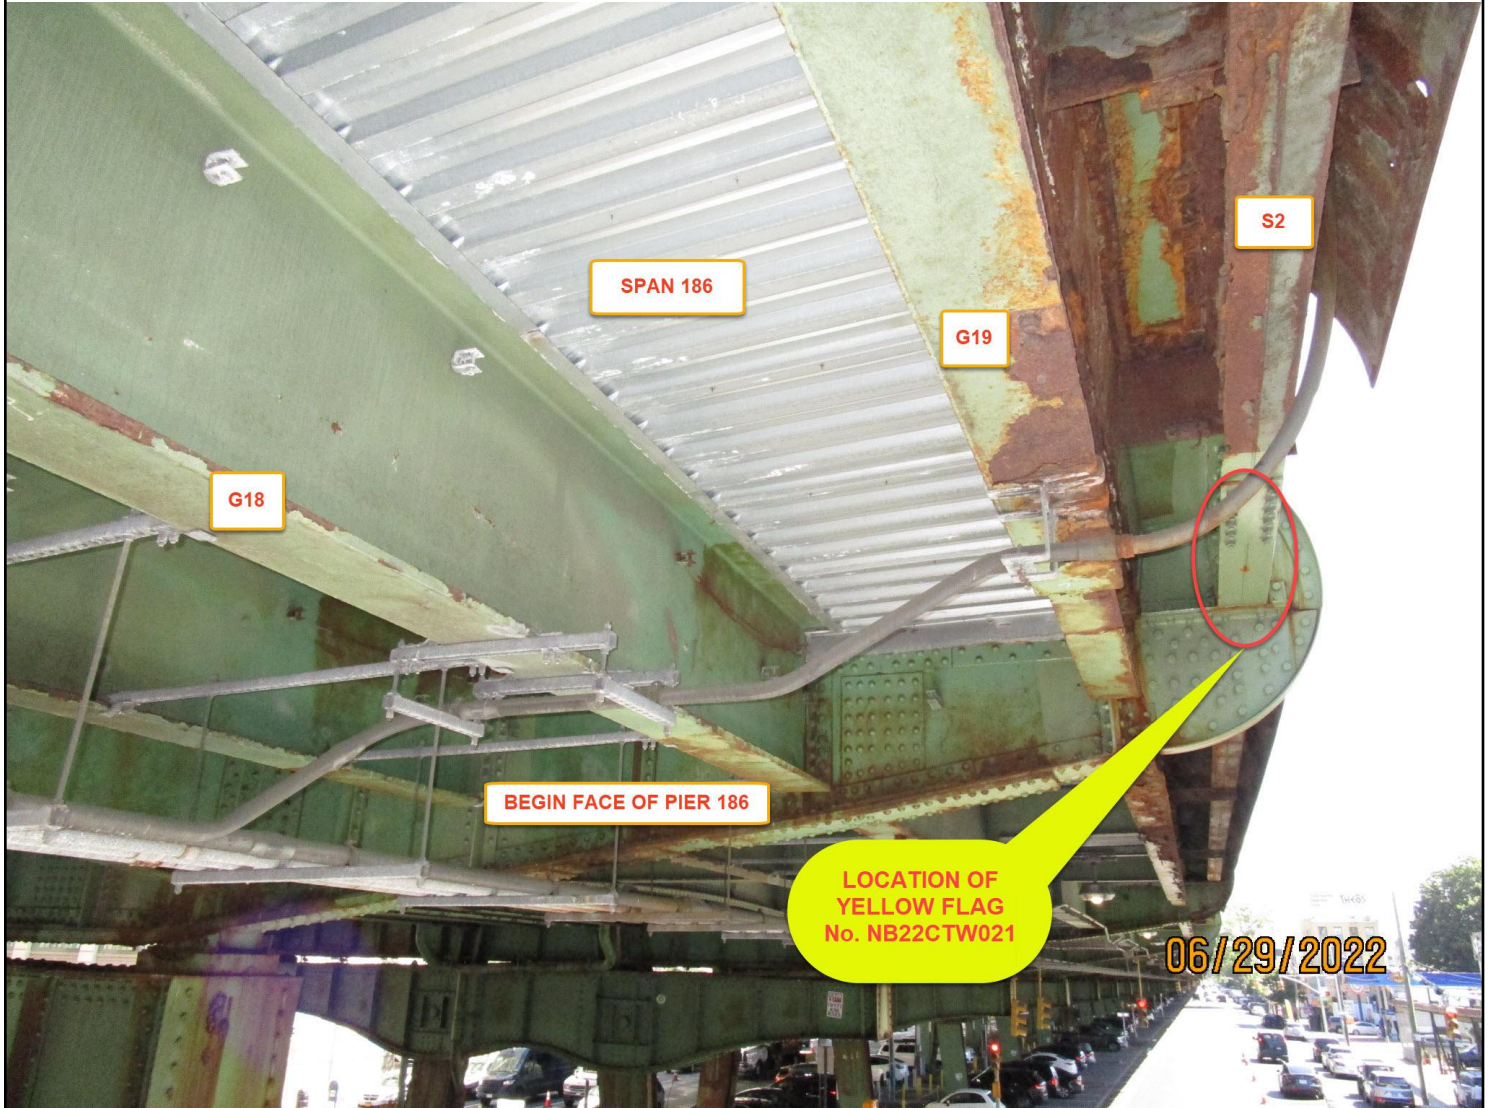
Photo Filename: Photo 1-RA 651_2282.jpg

Attachment Description: Location: General view of the flagged condition at Span 186 Stringer S2 at Pier 186. Looking End.

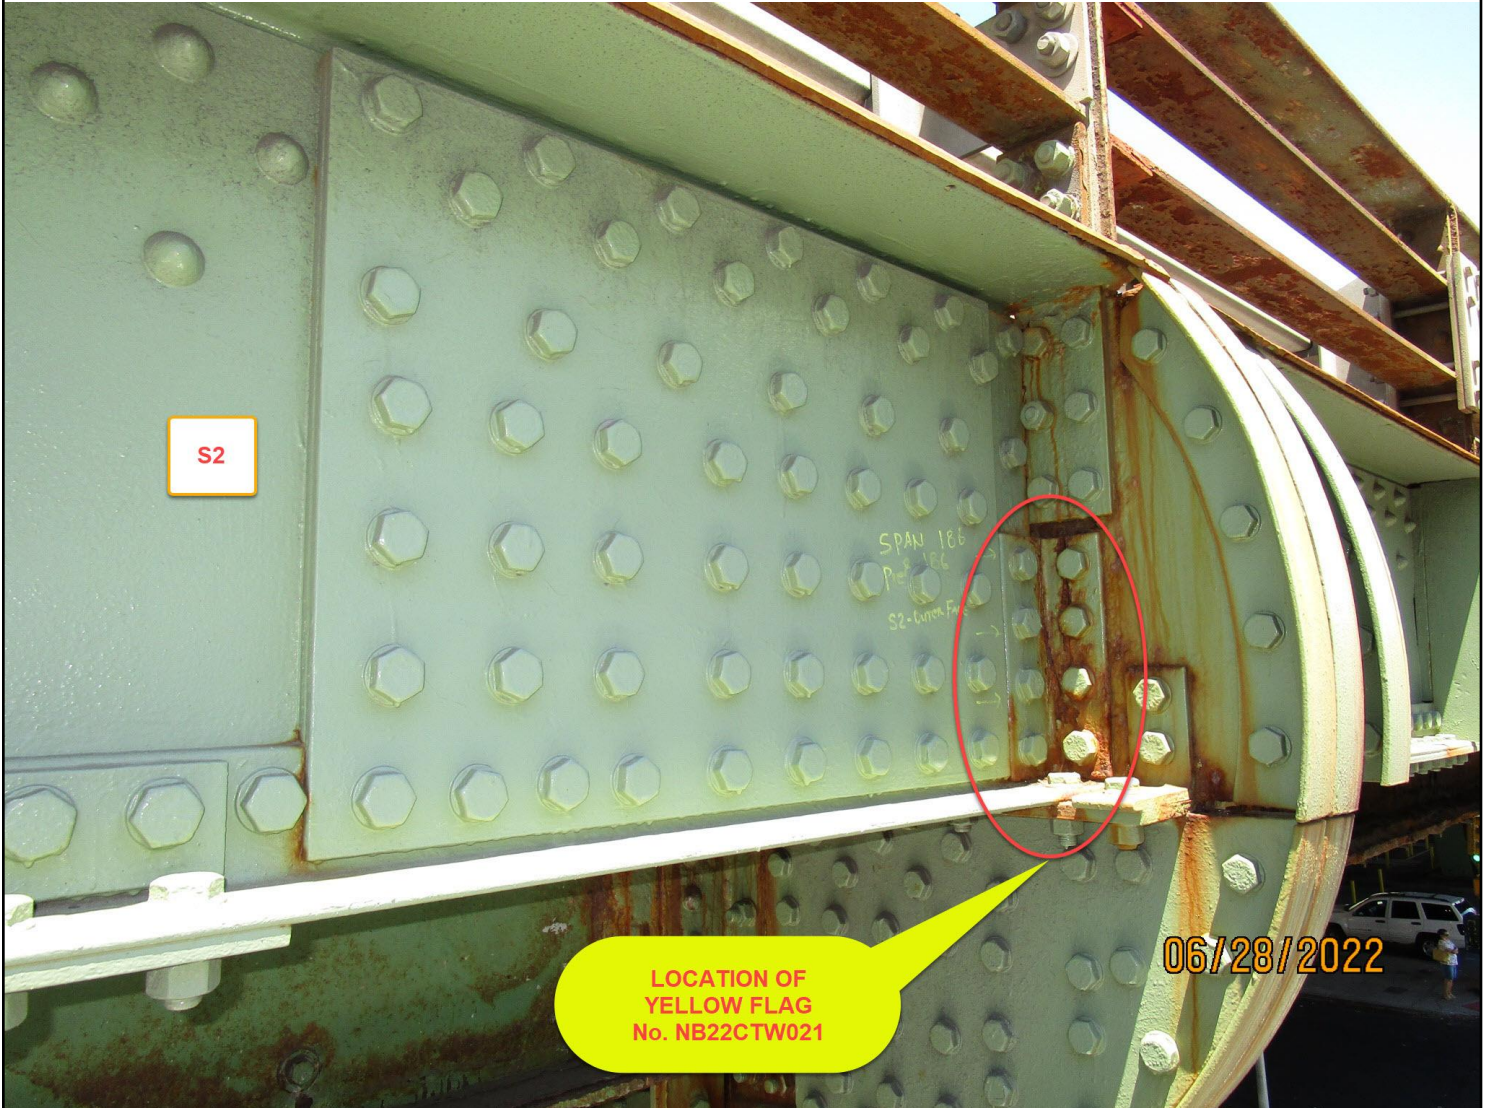
Photo Filename: Photo 2-RA 651_2246.jpg

Attachment Description: Location: Close up general view of the flagged condition at Span 186 Stringer S2 at Pier 186. Looking End - Left.

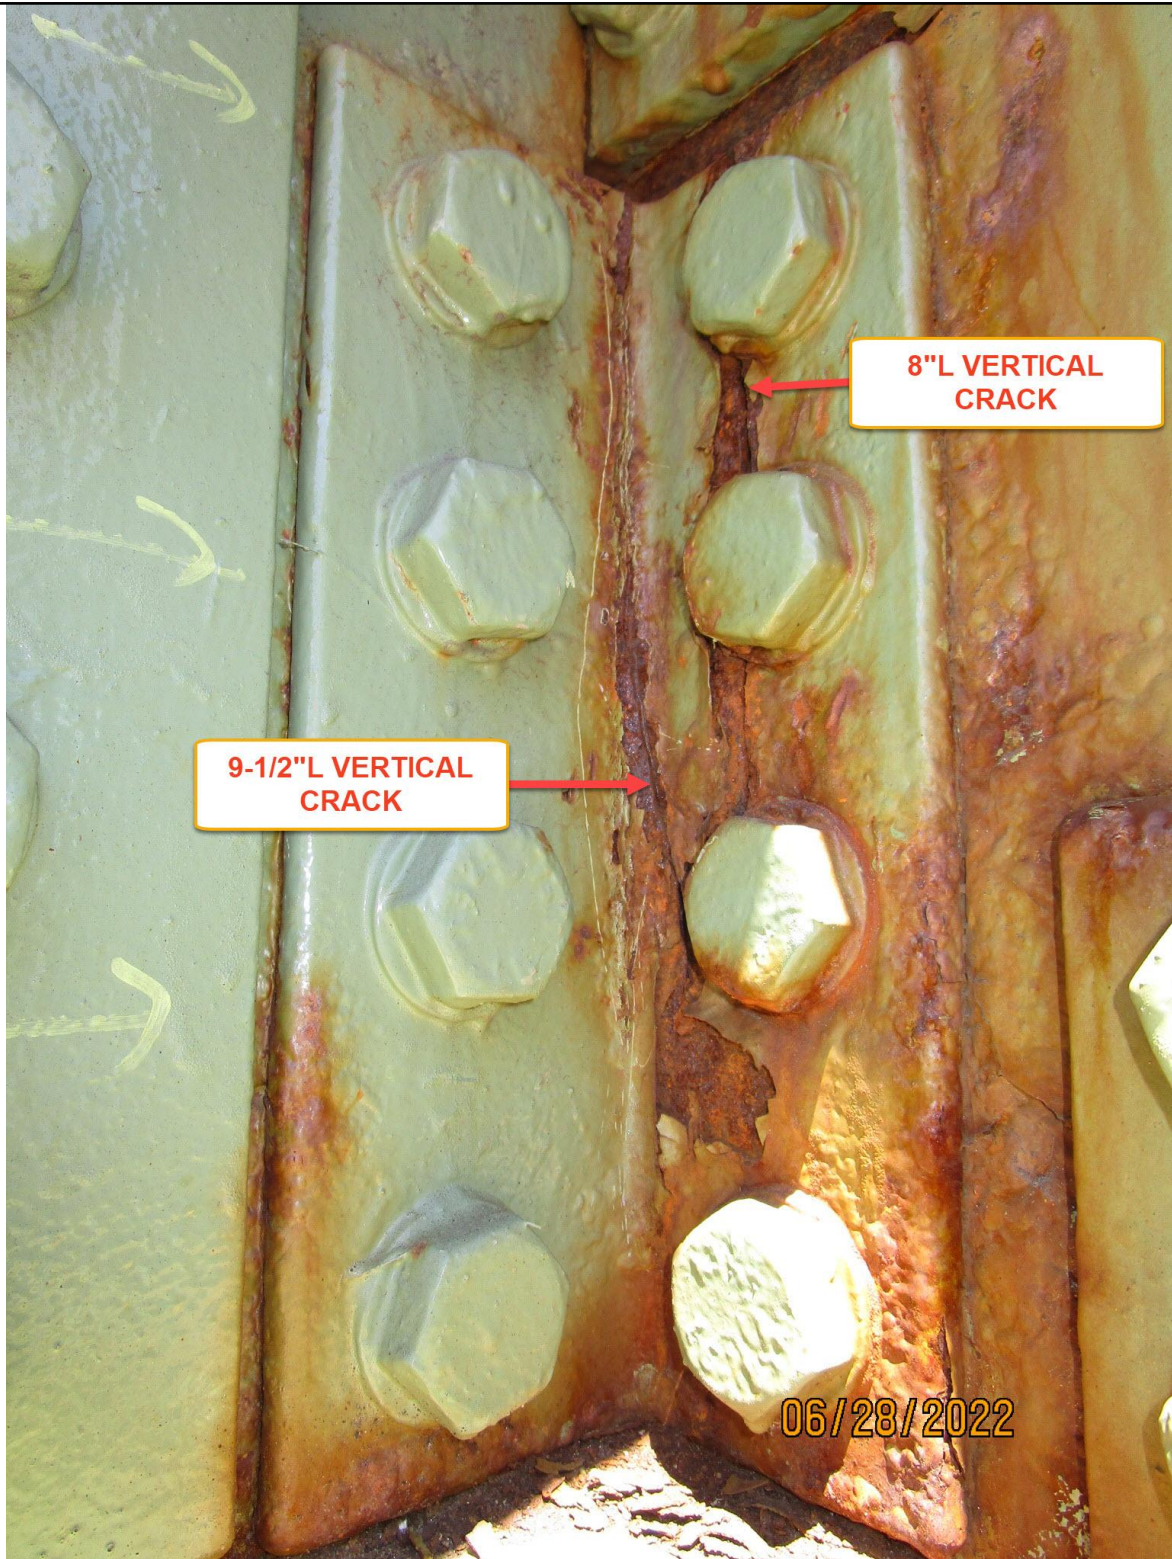
Photo Filename: Photo 3-RA 651_2248.jpg

Description: The end of Stringer S2 in Span 186 at Pier 186 exhibits two (2) vertical cracks at the right side connection angle, a 9-1/2"L crack and an 8"L crack (Photo 3). The Stringer S2 has repair plates at both faces of the web and at the bottom flange.

Attachment Description: Location: The end of Stringer S2 in Span 186 at Pier 186 exhibits two (2) vertical cracks at the right side connection angle, a 9-1/2"L crack and an 8"L crack. The Stringer S2 has repair plates at both faces of the web and at the bottom flange. Looking End-Left
